Rockwell International

**MATERIALS AND PROCESSES  
FAILURE ANALYSIS LABORATORY**

NUMBER PTN 027937

NOMENCLATURE/SUBJECT Evaluation of Laser Marked Vericodes on Turbine Blade

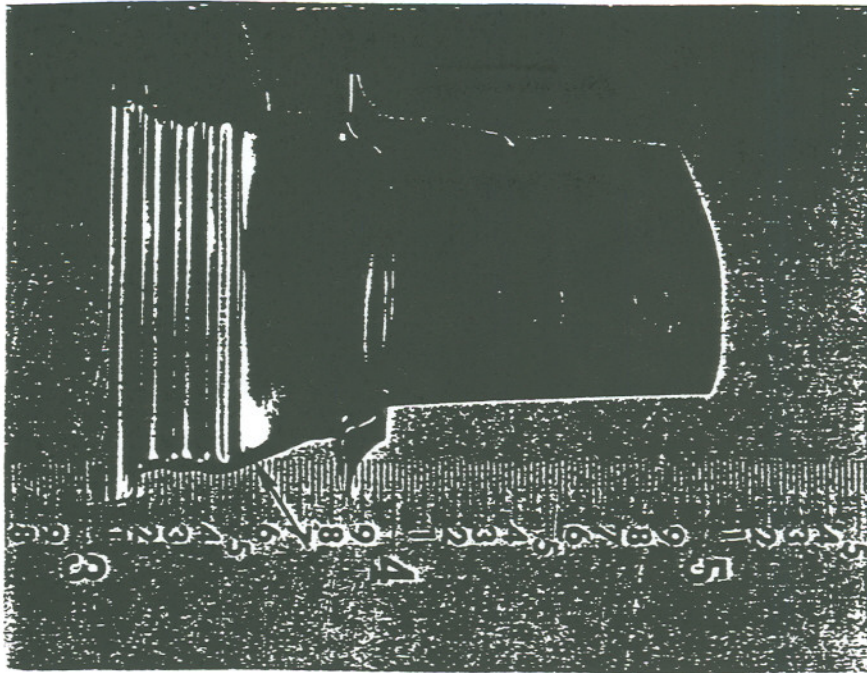
The overall turbine blade segment is shown in Figure 1. Two Vericode patterns had been laser cut into the part on the ends of the retainer. As shown in Figure 2, each of the Vericode patterns was approximately 2 mm square.

Figure 1. Overall view of the turbine blade segment with arrows showing the location of the two Vericode markings.

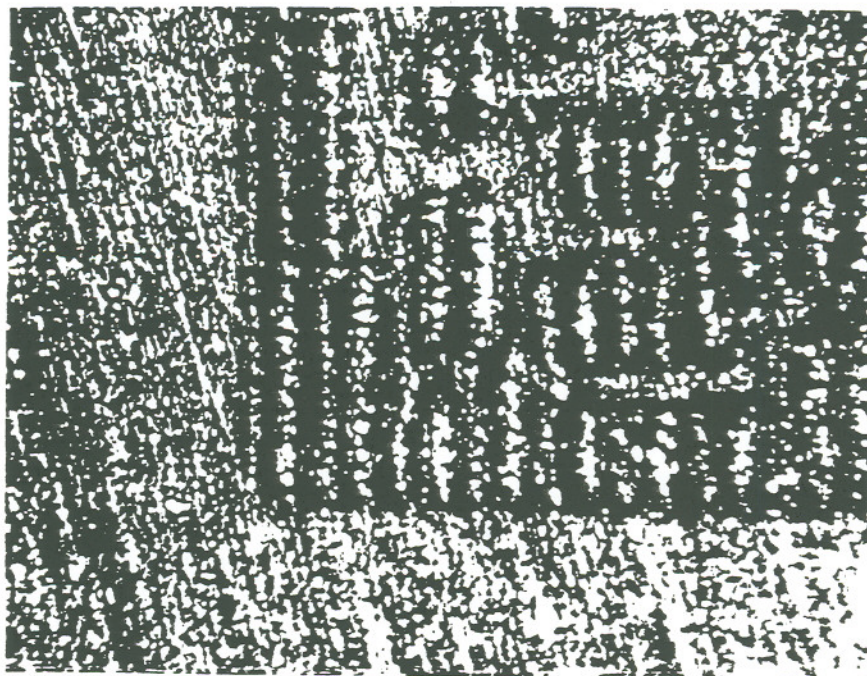
Under stereomicroscopic examination the laser marking appeared to create small overlapping 'dimples'. The pattern of application clearly indicated the direction of application with the overall appearance of the pattern being similar to a TIG weld. Refer to Figure 3.

Figure 3. Optical photomicrograph of a typical portion of the laser marked Vericode patterns.

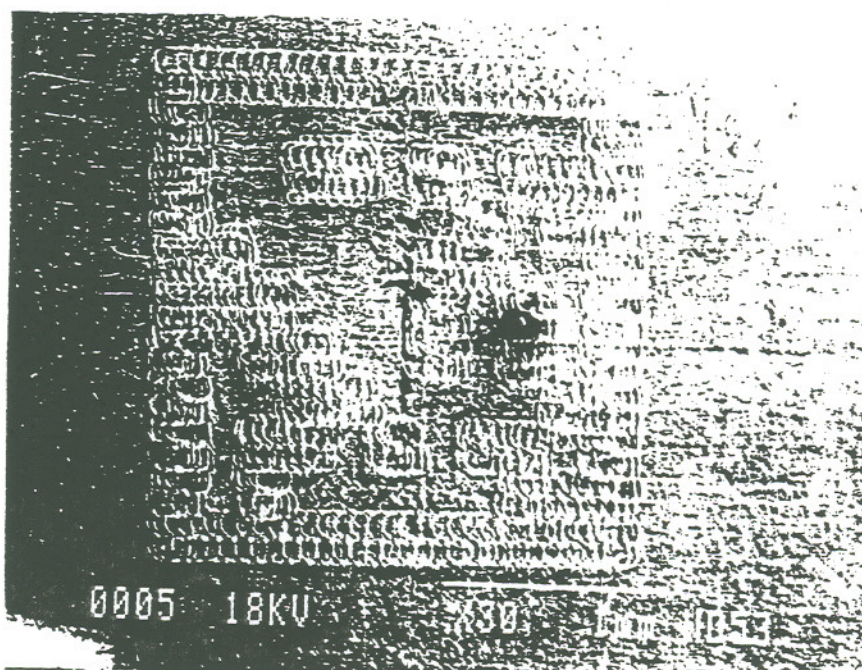
Figure 4. SEM photomicrograph of a typical laser marked Vericode pattern. The dark areas are SEM artifacts due to dirt.

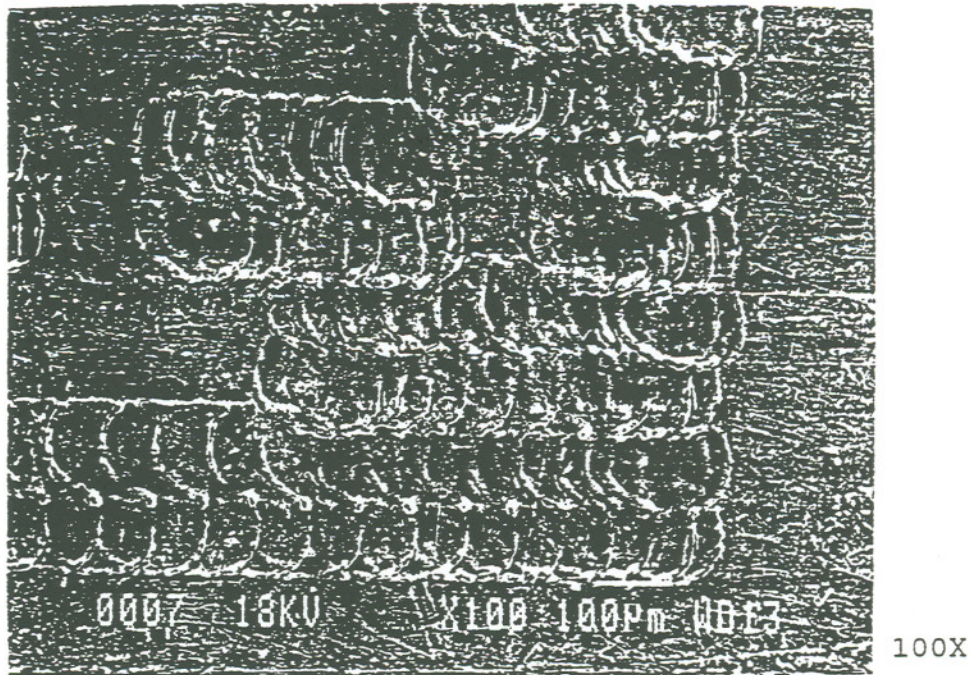
**Figure 5.** Higher magnification detail of a typical area of the Vericode patterns. The small melt craters created by the laser are readily apparent.

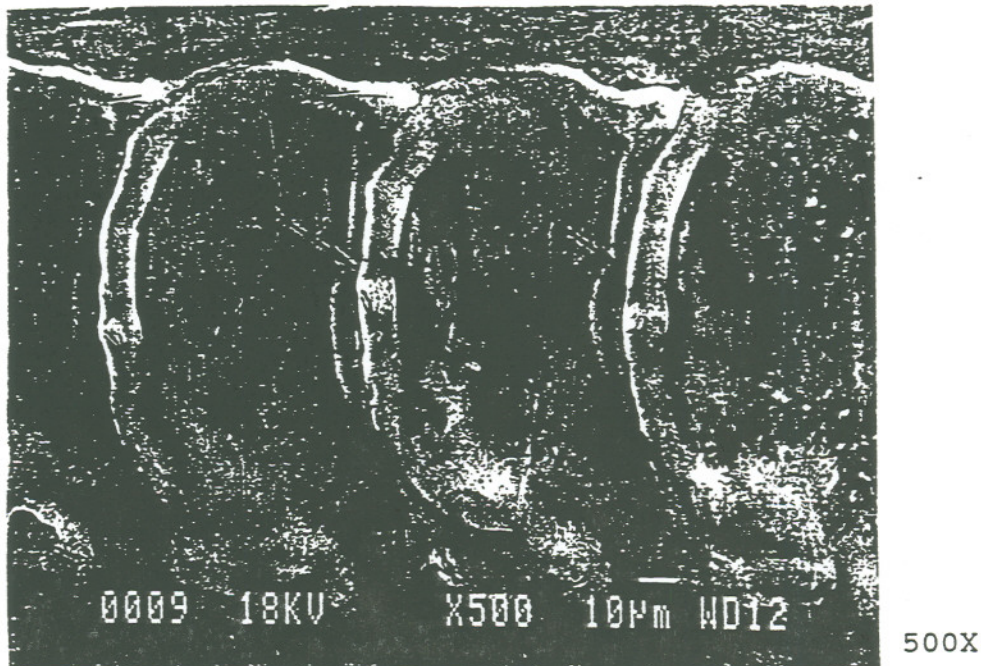
in Figures 4 through 7. No distinct cracking could be located on any portion of the Vericode patterns, but small folds of metal were found

along the edge of all laser cut spots. These did not appear to penetrate the substrate material, but rather were superficial fold of resolidified metal.

**Figure 6.** Higher magnification of the overlapping melt craters caused by the laser. Arrows locate small gaps along the edges of resolidified folds at the perimeter of the melt spots.

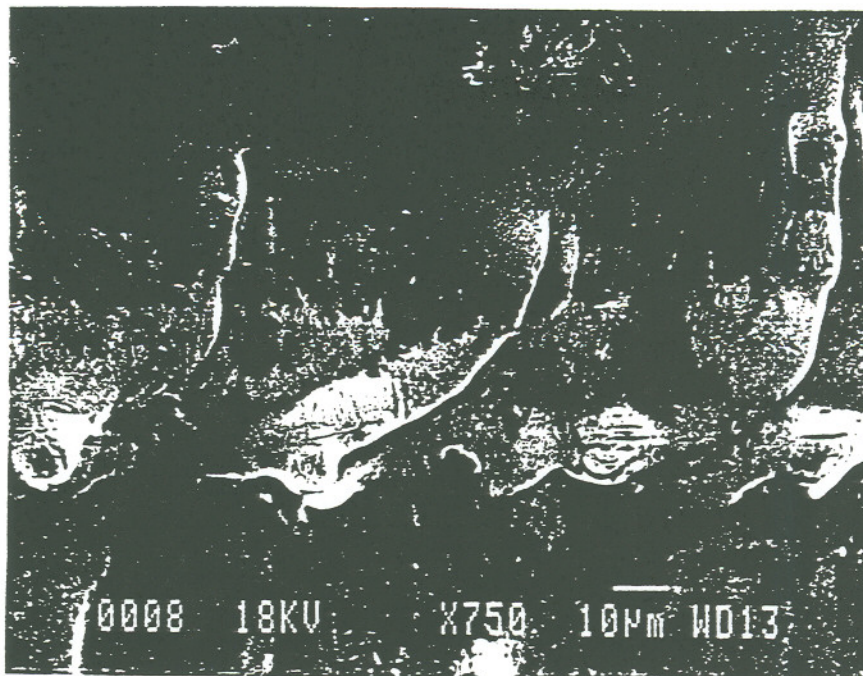
Figure 7. Another area of gaps along the resolidified folds at the edges of the melt spots.

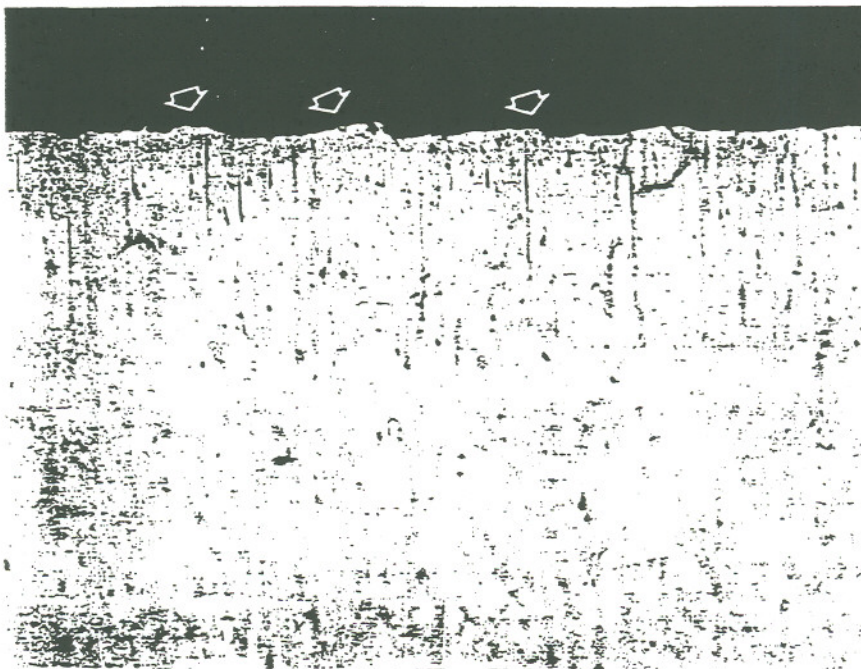
When viewed in the as-polished condition, only minor surface irregularity was observed. The maximum depth of apparent laser cutting was 0.0005 inch. In addition, no cracking was observed when inspected at magnifications up to 1000X.

Figure 8. Metallographic cross section through one of the laser marked Vericodes. Arrows locate the slight surface irregularity caused by the marking process. No cracks are apparent.

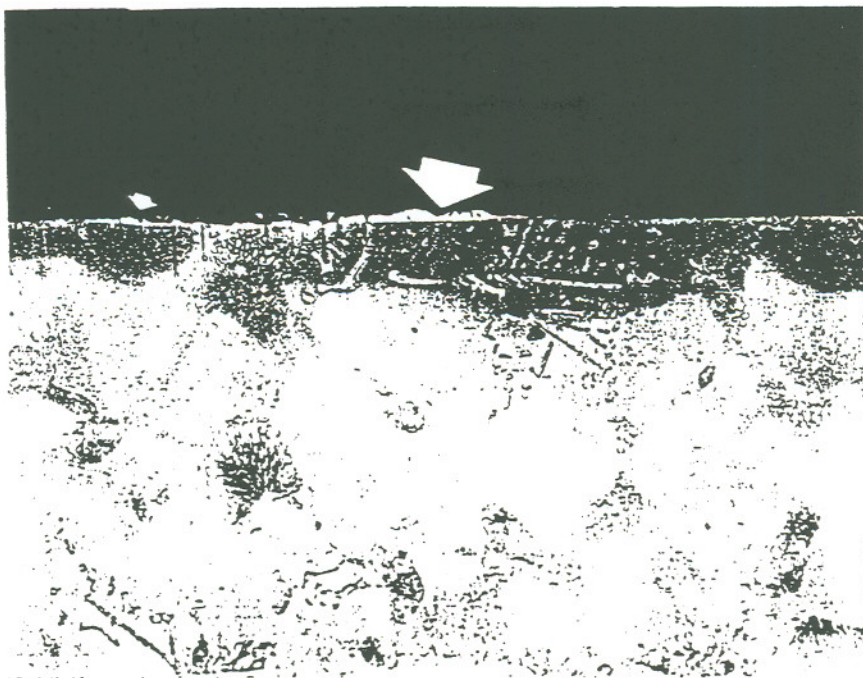
Etching of the polished cross sections clearly revealed the recast layer in the marked areas. The maximum depth of the recast material was 0.0005 inch and the apparent heat affected depth was roughly 0.0017 inch. Refer to Figures 8 through 11 for typical examples.

Figure 9. Similar view to the previous figure after etching. The white areas (arrows) are resolidified metal. The dark areas are the heat affected region.

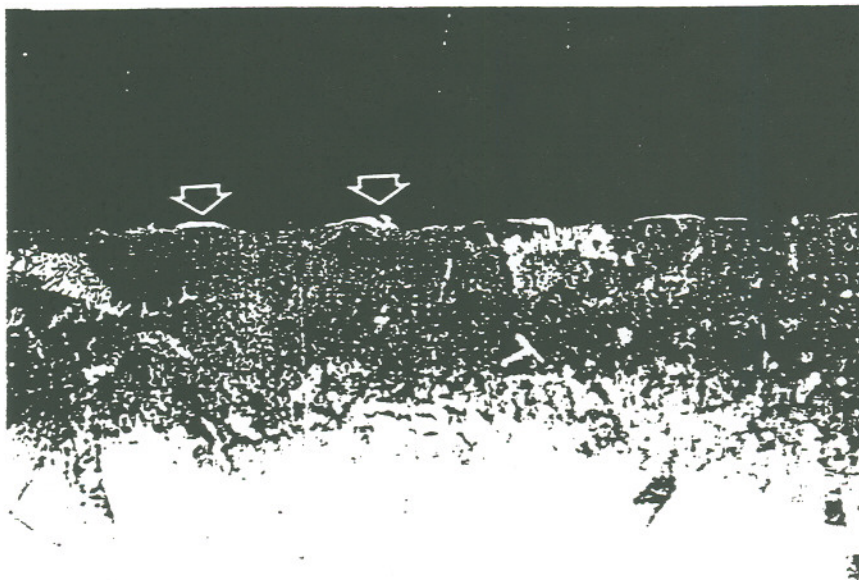
Figure 10. Another area similar to the previous figure. Arrows indicated areas of limited molten/resolidified material.

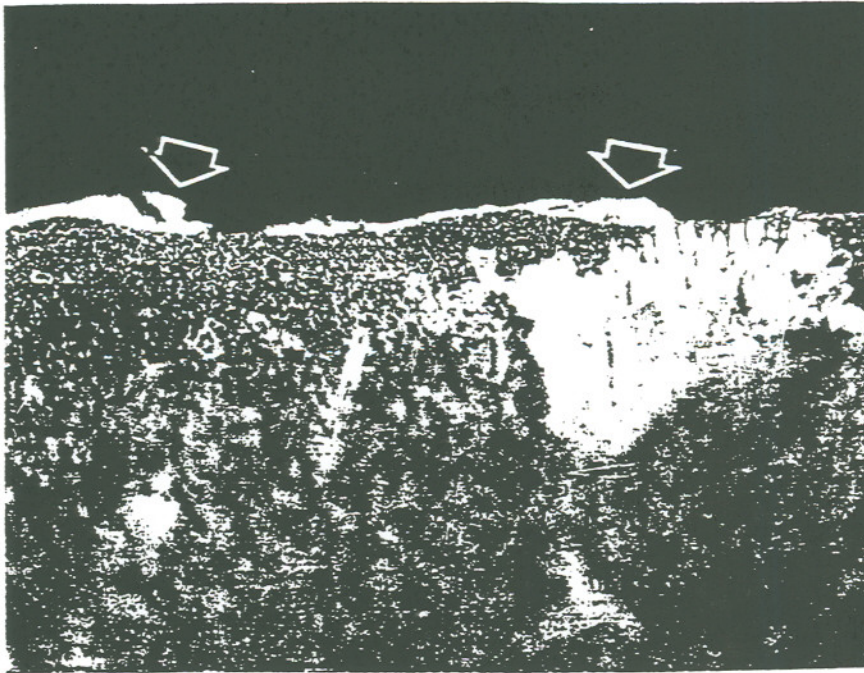
Figure 11. Higher magnification of the typical resolidified material (arrows).
